Durability of Autoclaved Cellulose Fiber Cement Composites

A M Cooke

This paper examines the determinants of durability of autoclaved Hatschek-made cellulose fiber reinforced cements (CFRC's) in the various US environments and reviews their performance.

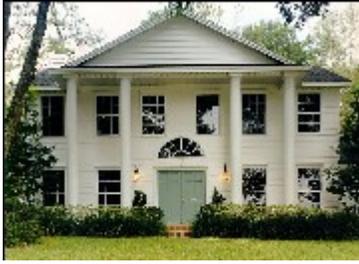
Figure 1: Fiber Cement Wall sidings

Fiber cement is used for roofing, wall claddings and internal linings in both domestic and commercial buildings. Most commonly it is used in the form of flat sheets, planks and shingles but it is also found as corrugated sheets for fencing and roofing. See Figures 1 & 2. Where used externally, fiber cement is normally painted or otherwise coated although this may not be the case for industrial or farm buildings.

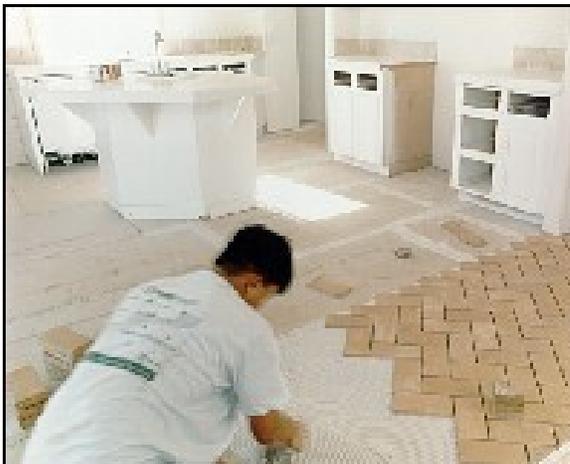
Figure 2: Fiber cement backer board for tiling

Fiber cement is immune to damage by water (unlike gypsum based lining boards) and this makes it particularly suitable for use behind tiling in wet areas. Fiber cement therefore, finds considerable use as backer boards for counter tops or wet area internal lining boards and these are usually covered and protected.

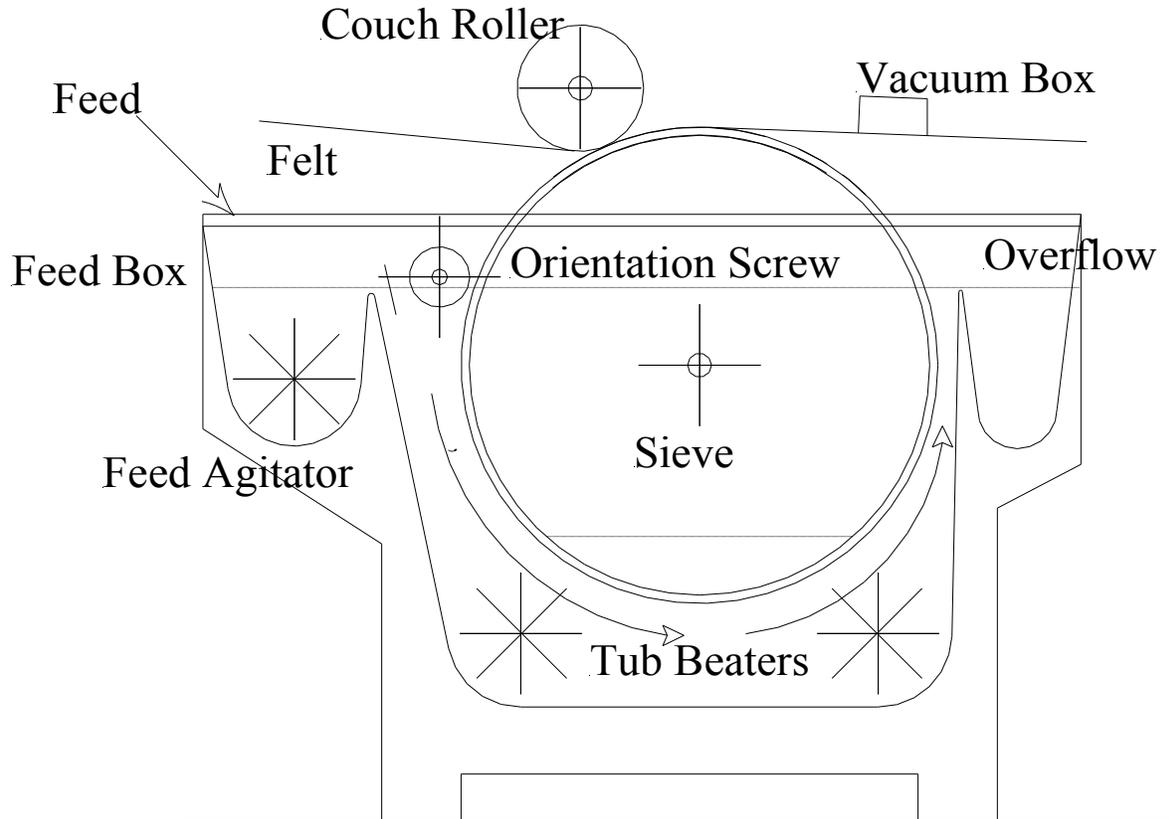
Figure 3: Schematic of Hatschek Machine

CFRC does not have an homogenous structure and this is a result of the manner of its formation on the Hatschek machine (Figure 3) by filtration of a dilute slurry of fibers and equidimensional sand and cement particles. This filtration process produces a film that is typically around 0.25 to 0.40 mm thick and each fiber cement sheet comprises a stack of these films. Thus, an 8 mm (5/16") thick sheet will consist of between 20 to 30 or more thin films.

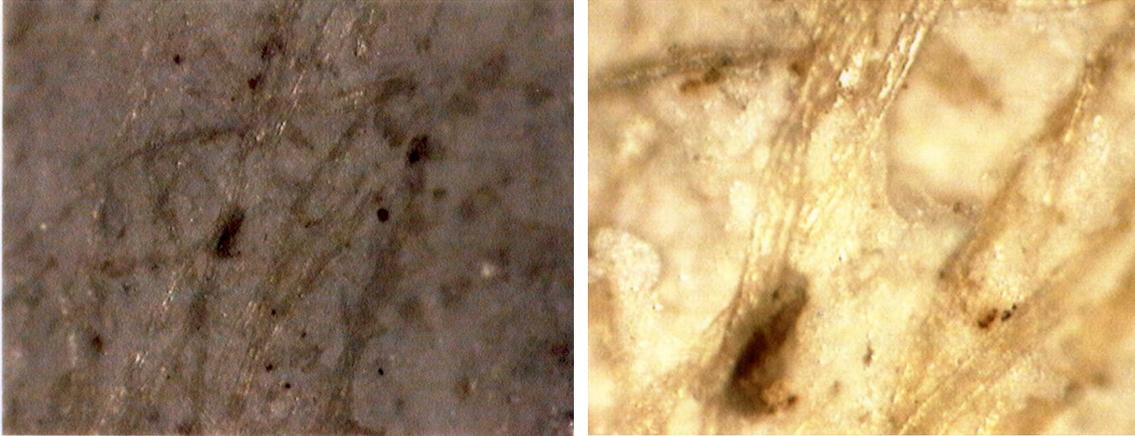
Figure 4 Surface of Hatschek Made Fiber Cement

Another consequence of the Hatschek process is that the front face of the sheet is also fiber rich and this may be seen in Figure 4 a photomicrograph of the front of a sheet.

It will be seen that the fiber rich portion of each film is brought into contact with the fiber poor portion of the adjacent film and because of this, the bond between films is relatively weak. The film-on-film structure of the sheet also means that Hatschek made fiber cement is much more permeable parallel to the plane of the sheet than perpendicular to the plane. One consequence of this structure is that fiber cement is susceptible to penetration by aggressive agents along its exposed edges.

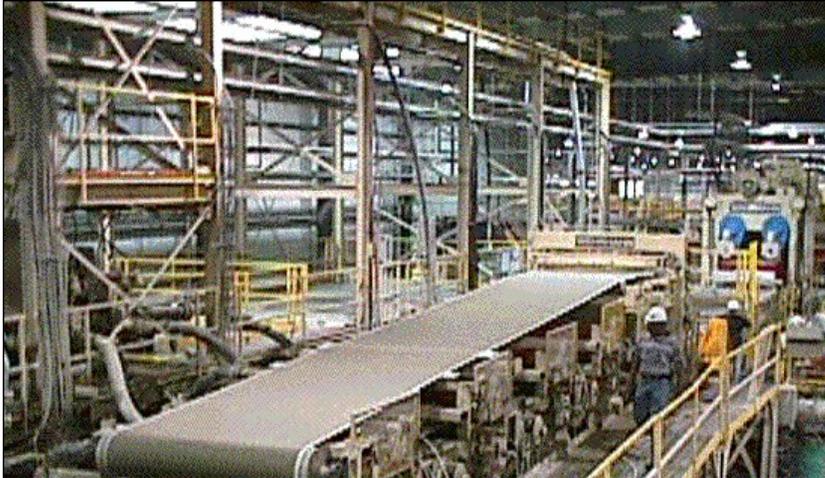
Figure 5:
4 Vat Hatschek
Machine

Stacking or wrapping of 20 to 30 films to form one sheet as single films would be very slow and most Hatschek machines have more than one vat so that a stack of 3 to 6 films is wrapped simultaneously. In these circumstances, the fiber orientation devices are set to orient the fibers to the opposite direction in each successive vat that ensures that the finished sheet is plied and its properties are symmetrical if not uniform in all directions. An idealized structure for successive plies or layers in the finished product is illustrated below in Figure 6. Figure 5 shows a typical Hatschek Machine.

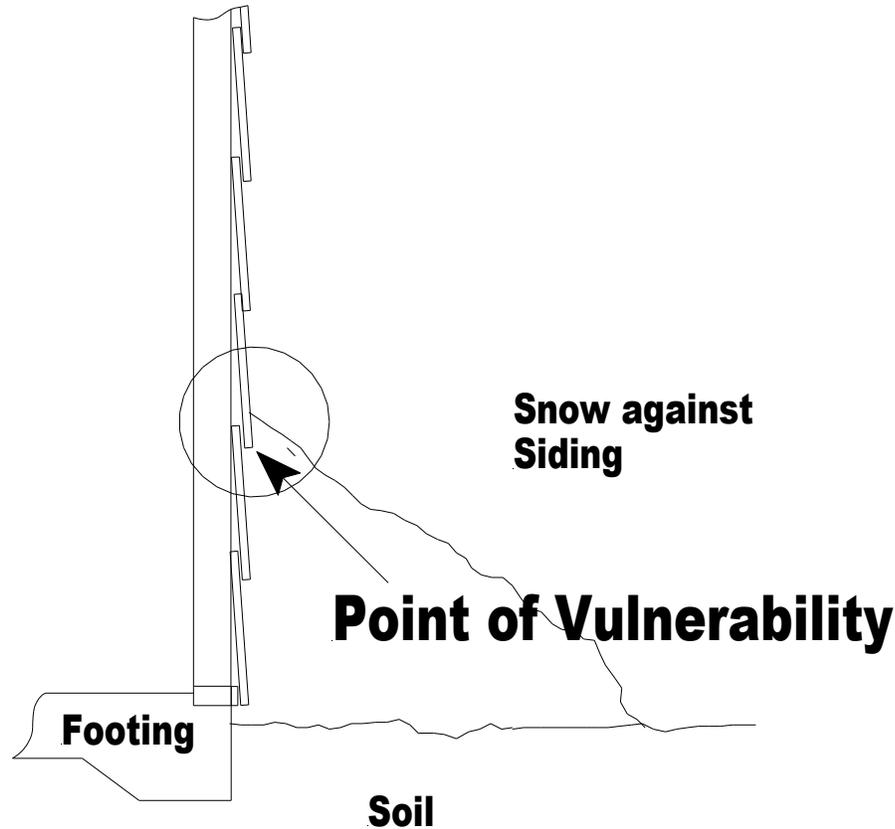
Figure 7: Snow drifted against a lap siding.

It seems to the author however, that the most vulnerable portion of a siding component is the edge of the sheet that has been installed close to the ground where there is a possibility of snow lying against it. See Figure 7

At this position, the edge of the sheet is exposed to liquid water whenever the snow melts and penetration of water into the sheet is a real possibility. Furthermore although the sheet may be painted, full cover of the edge with paint cannot be guaranteed and the coating is likely to be thin at this point. Thus, there is a chance of freeze thaw damage at this place.

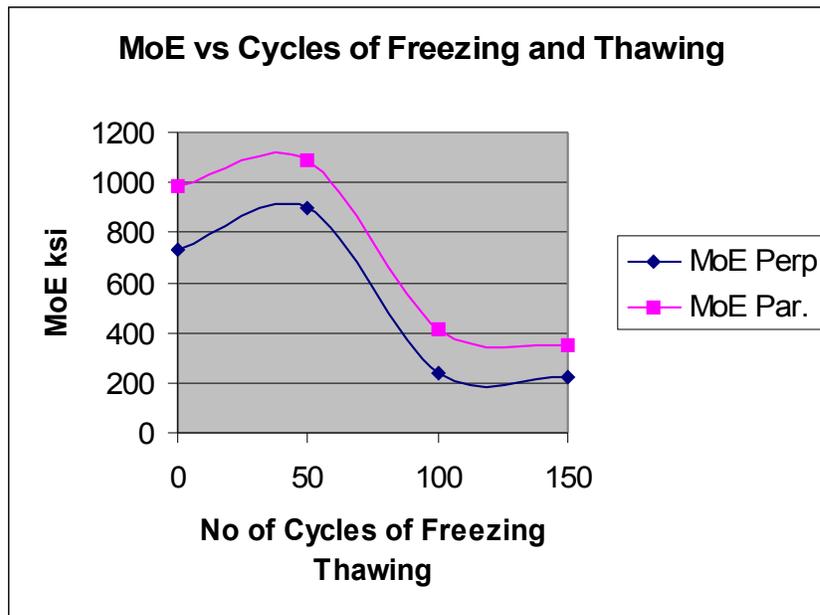
Figure 8: Response the Modulus of Elasticity of fiber cement to cycles of freezing and thawing.

Let us now consider the actual vulnerability of fiber cement to freeze thaw damage. We have included in graphical form the effects of freeze thaw on the Modulus of Elasticity of fiber cement. See Figure 8. The testing was conducted as follows.

5. The test specimens were subjected to a further 50 cycles of freezing and thawing and their flexural modulus of elasticity was determined as described in 4. Some of the specimens broke during the testing and the maximum load to which the remaining specimens were subjected was therefore reduced to avoid further breakage.

6. The specimens were then returned for a further 50 cycles of freezing and thawing.
7. After 150 cycles of freezing and thawing it was found that no specimens could withstand the determined maximum load (40% of the original undamaged strength) and all of them were broken. Therefore, the test was terminated.

The test was set up to simulate the conditions that may exist in the real world where typically a material will not be saturated at each cycle and neither will it be dry internally. It will be seen that the specimens tend to a limiting condition after about 100 cycles. Admittedly, the specimens are considerably weakened but they remained

intact and showed only limited signs of delamination. The results of the tests show that the specimens can be subjected to reasonable freeze thaw when there is access to liquid water with low damage.

Tests where dry specimens are exposed cycles of freezing and thawing show essentially no damage from this treatment. Combining these results indicates that protected lap siding can be exposed to the worst freeze thaw conditions in the USA with little likelihood of freeze thaw damage. This is dependent on the maintenance of protective coatings to some extent but also relies on the fact that the fiber cement is installed in favorable conditions and has moderate freeze thaw resistance.

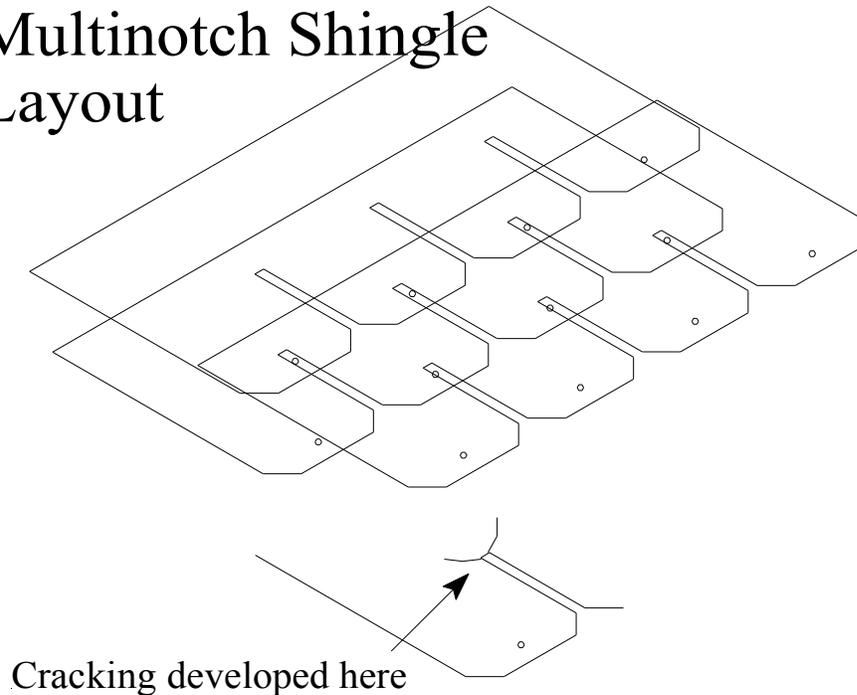
Figure 9: Multinotch Fiber Cement Shingle

The third installation was over a large swimming pool complex and this tended to keep the underside of the shingles moist. The climate of the area is also dry and hot in the summer time so that the shingles were kept dry on the top and moist underneath. These shingles showed signs of severe distress within 18 months of their installation. The ends of the shingles curled and many of them tore out their fixings. Some of the tabs actually broke off and came off the roof. Shingles that were removed intact, showed cracking in the head of the notch that often progressed up the shingle. Vertical cracking also appeared to be a precursor of cracking across the shingle and these cracks resulted in the loss of the protruding tab. The problem was resolved by replacing the damaged shingles with a revised design where the notch between tabs was radiused rather being square cut. However, it was clear that the failure had resulted from a combination of factors and while the revised notch design helped, it did not resolve the problem entirely. Eventually, a decision was made to quit this type of shingle because of its inherent deficiencies. Figure 9 illustrates.

Multinotch Shingle Layout
